PROJECT DETAILS

VERTICAL STOPE RECOVERY QUEENSLAND.

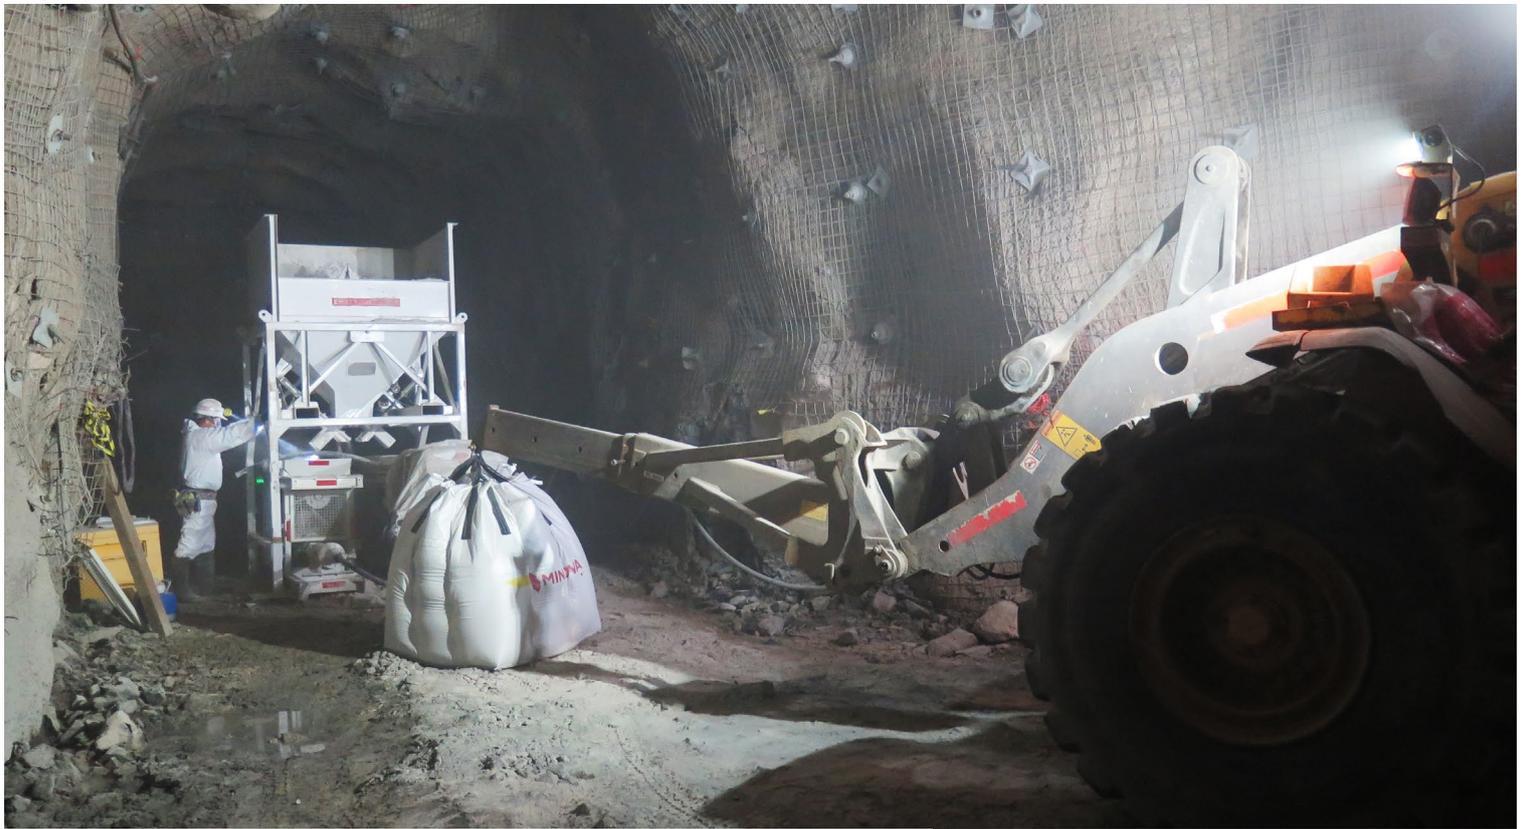
Working with Minova, the mine was able to develop a plan which would allow the failed stope to be stabilised, creating a solid rib pillar against the secondary stope to be mined. Designed at 1 m thickness, the rib pillar's purpose was to minimise dilution of the secondary stope.

Rings of injection holes were drilled from an adjacent cuddy to intersect the vertical face of the failed stope. A pre-determined volume of FB200 grout was injected into each hole, with the stope grouted from the bottom to the crown in a sequential process.

Mobilised to site once the injection holes had been drilled, Minova worked with the mine to grout the failed stope with FB200 high yield grout.

Minova was able to stabilise the failed rock within the stope, allowing mining of the adjacent secondary stope to occur.

A rib pillar of 1 m was designed adjacent to the stabilised stope to protect it from production blasting. During extraction, the FB200 stabilised rock remained competent, with minimal dilution observed at the toe of the stope.
