# CASE STUDY

## SLOPES & EMBANKMENTS

Blakedown Culvert,  
Worcestershire - UK

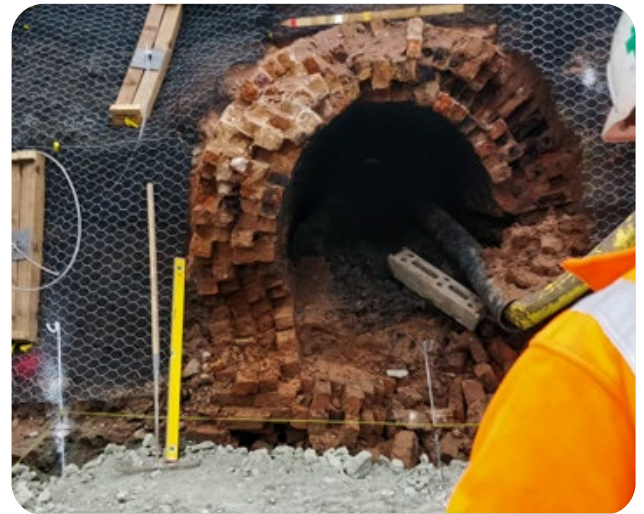
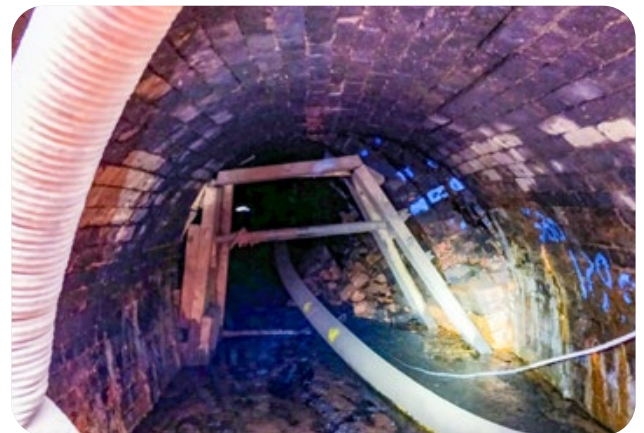
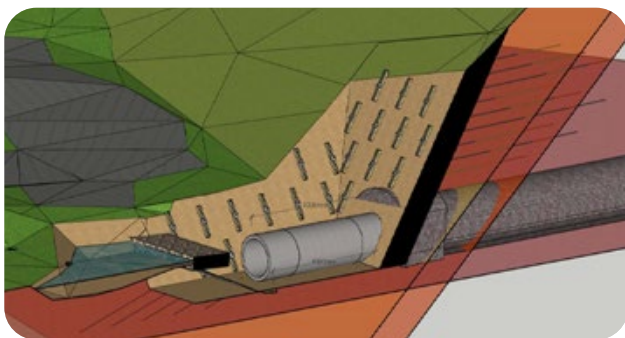
10m beneath a railway line an unstable culvert required refurbishment. The culvert, with a 1.7m diameter and 47m length, had collapsed in places becoming too unstable to be desilted. To safely refurbish the culvert, concrete pipe jacking would be used. In preparation, a temporary 6.5m high 60° anchored cut face slope would be needed. On-site training would also be provided during anchor suitability testing, allowing the Contractor to conduct the live installation without delay.

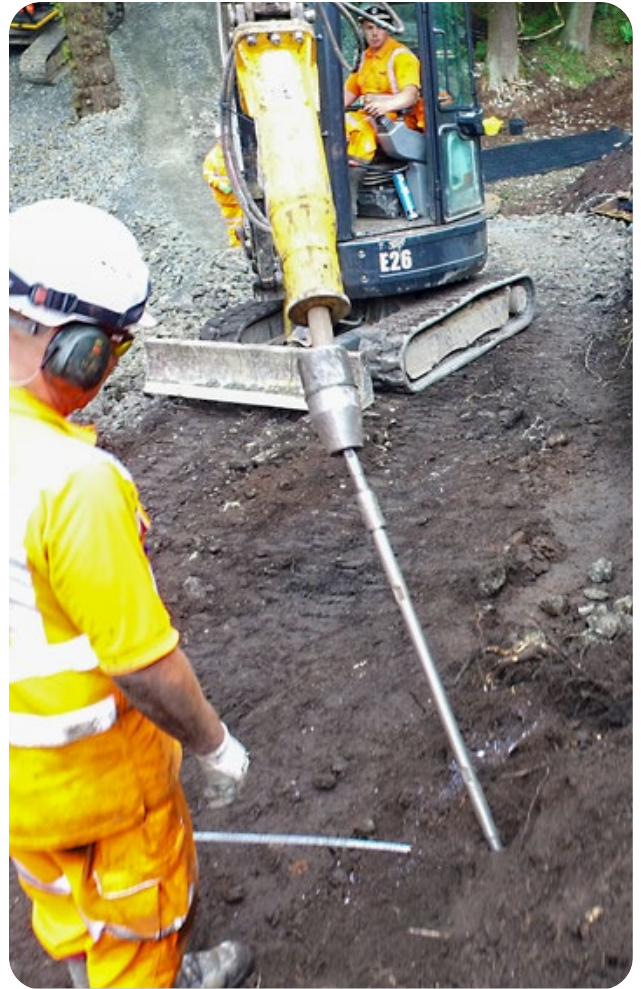
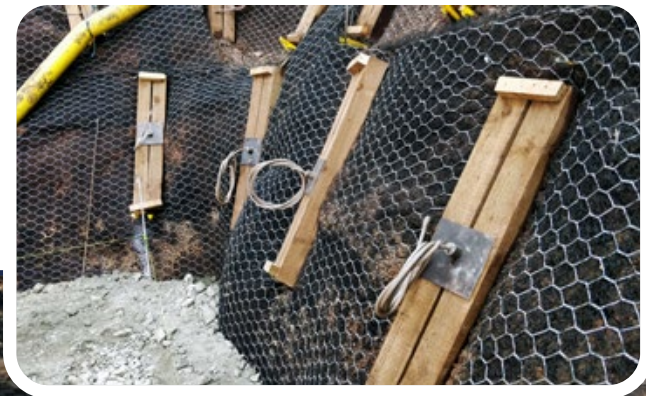
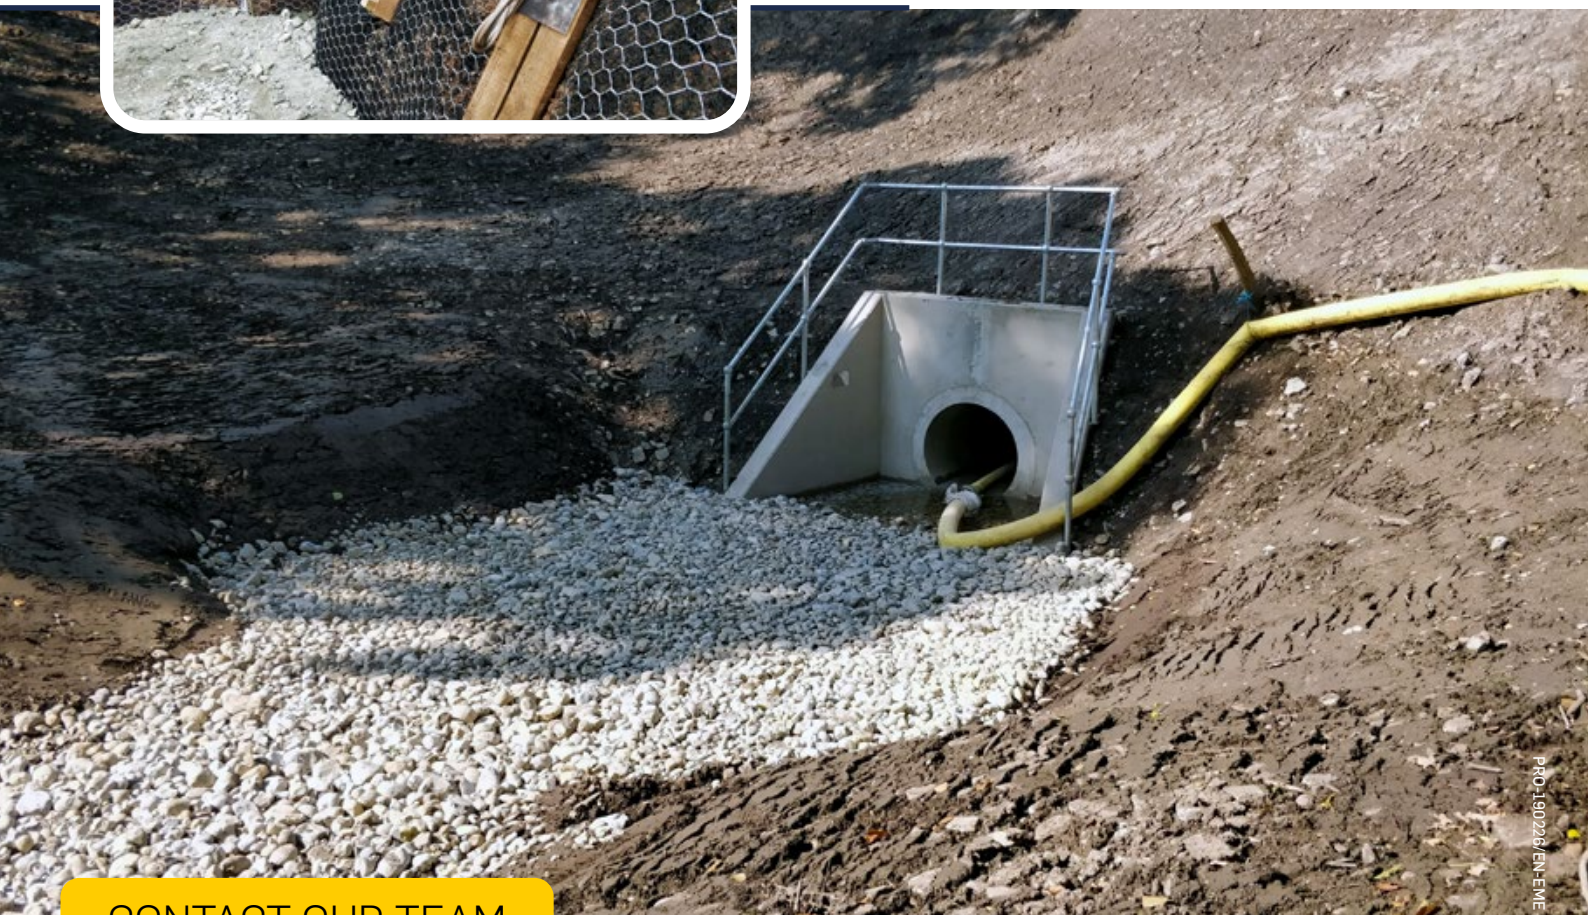
A combination of anchors with wire tendons and mesh reinforcement was used, with timber soldiers to spread the load from the anchors. A total of 67 Platipus Stealth anchors were installed to a depth of 7m using a tracked excavator. The working load of anchors varied between 40kN or 48kN. Temporary anchoring of the cut face slope facilitated concrete pipe jacking and headwall works to safely take place on the culvert. Once works were complete, the anchors were destressed, the mesh reinforcement removed, and the slope reinstated.
