CASE STUDY

SLOPES & EMBANKMENTS

Franklands Embankment,
Burgess Hill, West Sussex - UK

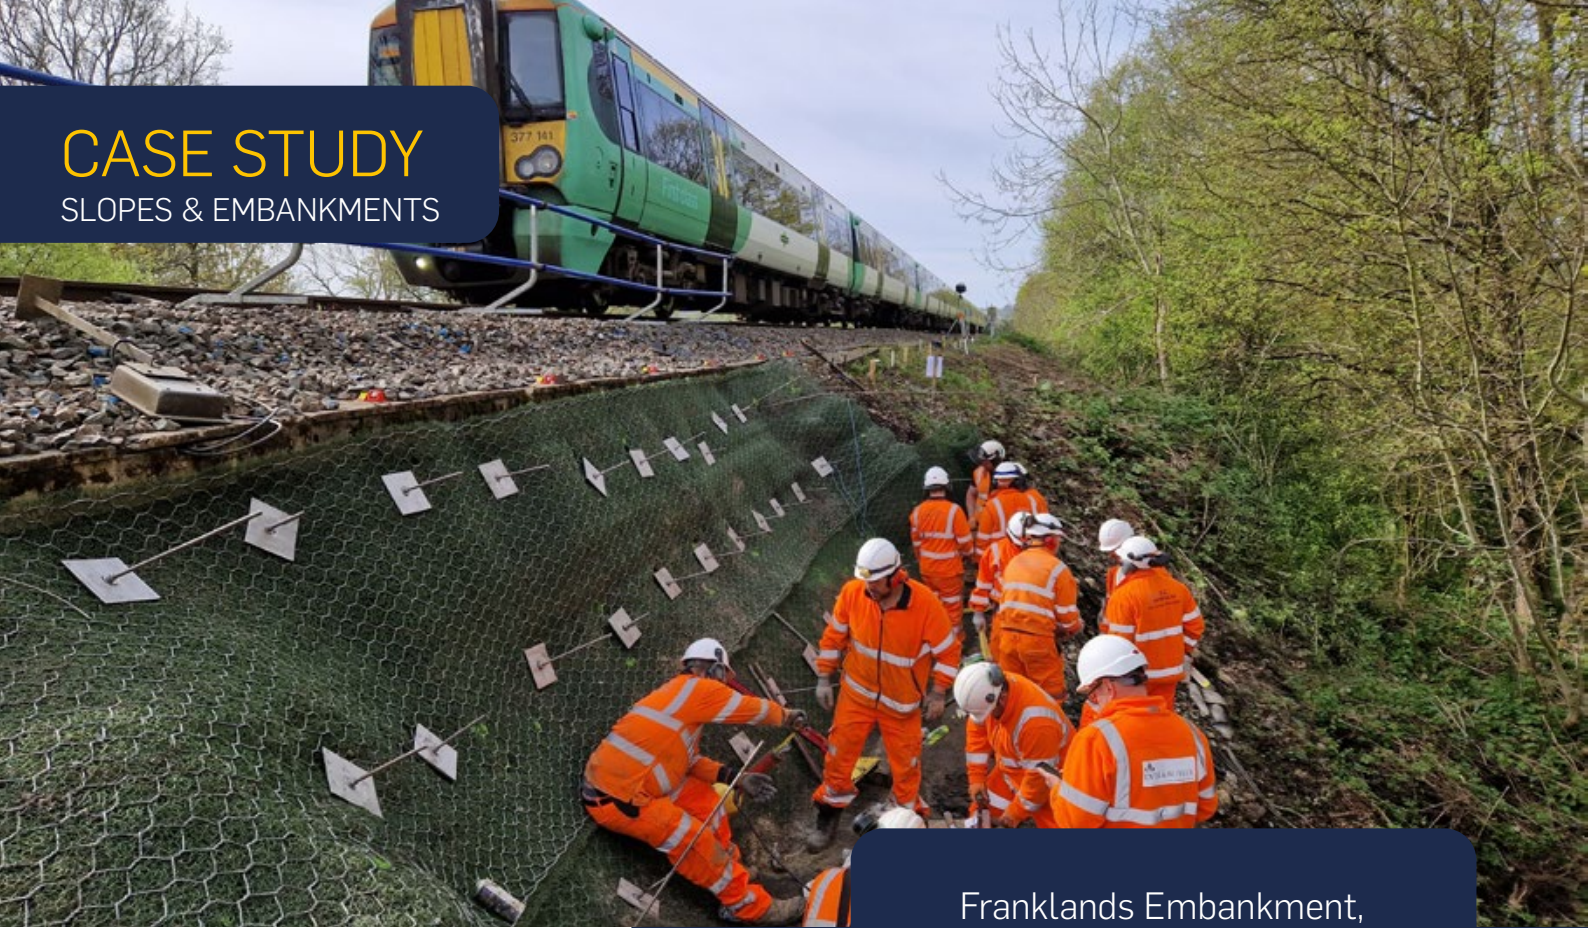
A slip occurred below an existing troughing route at the crest of this railway embankment, resulting in a temporary speed restriction, and leaving an exposed soil surface. This prompted emergency works to take place to prevent further erosion of the embankment. The area of embankment requiring remediation covered a 22m linear stretch at 4m high and a 60° angle. The residual slope material had slumped towards the toe and was held in place by an established tree line. An immediate solution was required on the embankment to prevent erosion from undermining the Brighton Line. Further complications were encountered due to access constraints, meaning all installation would need to be completed with handheld machinery.

The chosen solution involved the installation of 40 Platipus Stealth anchor systems, achieving a 6m drive depth with handheld equipment despite the exceptionally hard strata present on site. The anchors were positioned in 4 rows with 0.8m spacing securing the reinforced geomat on the embankment surface. They were then loadlocked

to a verifiable working load of 11kN. Platipus Percussion Driven Earth Anchors (PDEA®) are immediately serviceable, with no wait or curing times necessary. These emergency works were completed within one week from the first report of the slip.
