## CASE STUDY

# BUOYANCY CONTROL

Oldcotes Bylth Road Pumping Station,  
Worksop, Nottinghamshire - UK

Lokset, All Thread Bar, R32 Hollow Bar,  
Geoflex & Platipus Pipe Tensioning Kit

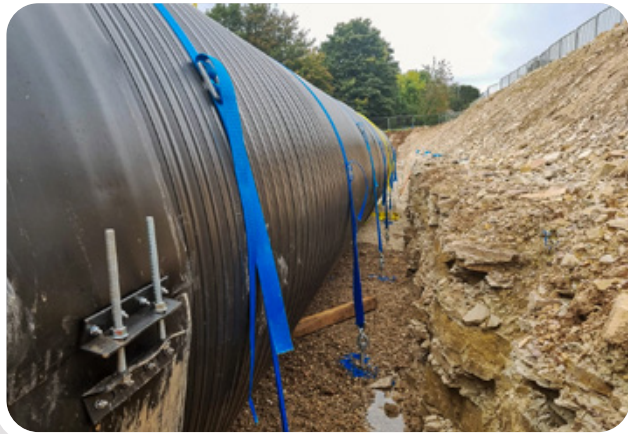
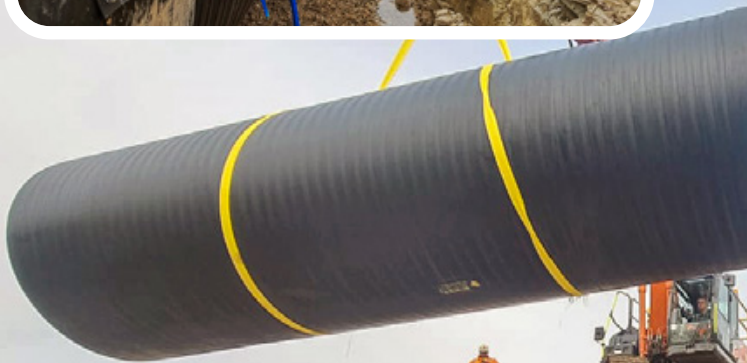
to be tested immediately after curing, even where flowing groundwater was present. With the pipes in place, **The Platipus Pipe Tensioning Kit was positioned over the pipe crown** and through the anchor system to secure the pipe and prevent uplift. This system successfully overcame the challenging ground conditions on site, and secured the attenuation system against uplift.

Once excavations were complete, Platipus Approved Installer Vertical Access could begin installation of anchors. In competent rock locations, **Minova Lokset resin was used alongside All Thread Bar (ATB).** However, in faulted and water-bearing sections a solution was devised using **R32 galvanised Minova hollow bars, 55mm drill bits, and Minova Geoflex, a two-component silicate injection resin capable of curing underwater.** This specialist resin prevented washout in fault zones, and allowed anchors
