CASE STUDY

Minova were contacted by BHP Billiton in March 2012 to assist during the April Clark Shaft shutdown to repair and rehabilitate the badly damaged walls within the ore pocket and chamber below the Clark Crusher. Olympic Dam was a major gold, copper, silver and uranium-producing mine in Northern South Australia, located approximately 600 km north of Adelaide.

BHP Olympic Dam
Billiton, Australia

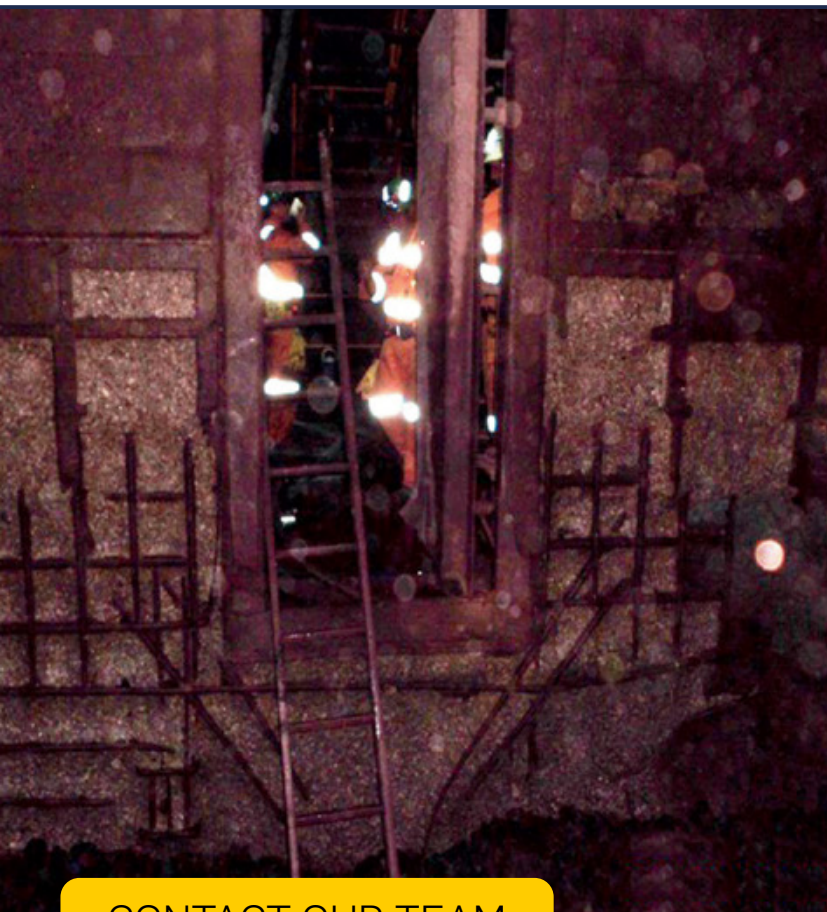
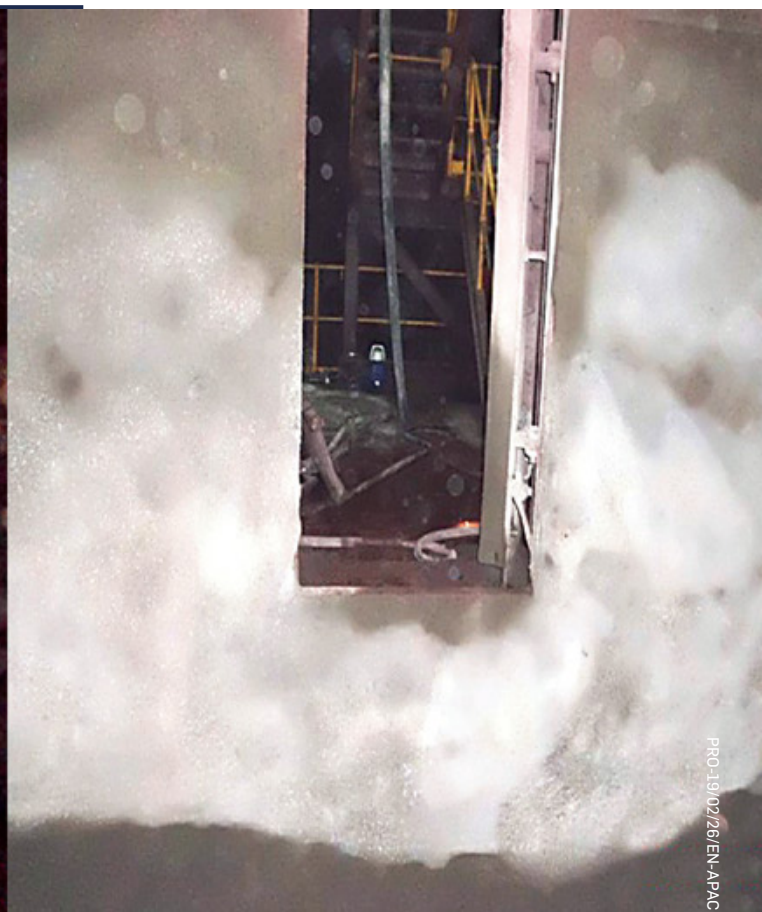
The walls of the chamber had been severely damaged by the continuous impact of ore dropping into the circular chamber from the crusher several metres above. The original concrete wall material had been worn away to, and in some areas past, the original steel reinforcement.

In certain locations even the reinforcement itself had worn away. Minova's experience with similar issues allowed us to quickly organise and implement a solution ahead of the imminent shutdown.

Minova recommended Rappass as the solution for BHP. Rappass was a specially formulated cement product engineered to deliver exceptional impact and abrasion resistance. It could be manufactured in a pourable grade, as a wet-mix shotcrete, or as a dry shotcrete. For the repairs at Olympic Dam, a dry shotcrete mix was selected. This provided high early strength, extremely high final strength, and the ability to achieve high build in a single pass with very little rebound.

A two-man crew carried out the application (one pump operator and one nozzleman) using a Reed pump. Approximately ten pallets of Rappass were used in the repair. Including preparation of the area, such as cleaning and exposing the damaged surfaces,

the application was completed over two shifts to lower the level of remnant ore in the chamber and expose further areas of wear.
