CASE STUDY

RETAINING STRUCTURES

The Hermitage, Petworth,
West Sussex - UK

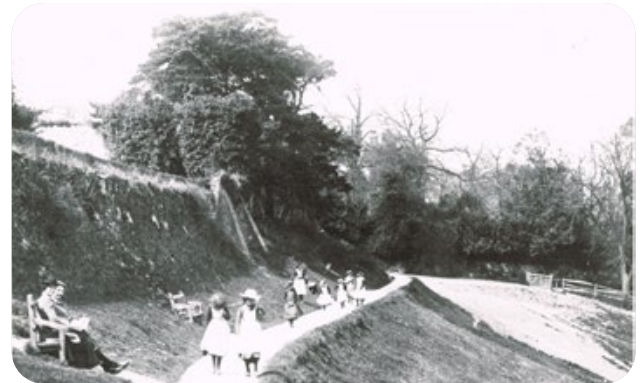
A mass sandstone wall, constructed in the late 1700's overlooking the Shimmings Valley, suffered a small collapse, with blocks of sandstone rolling into a well used public footpath. Original proposals to replace the entire wall were deemed impractical due to restrictive access and costs. Given the soil properties at the site, Platipus Percussion Driven Earth Anchors (PDEA®) became a more viable option. The wall measuring 76m in length and retaining up to 3.8m height in some areas,

required reconstruction of the collapsed area, strengthening of the existing wall, underpinning of the buttresses as well as rebuilding of a 0.9m high parapet.
