# CASE STUDY

## SLOPES & EMBANKMENTS

Thrapston Noise Attenuation Bund,  
Northamptonshire - UK

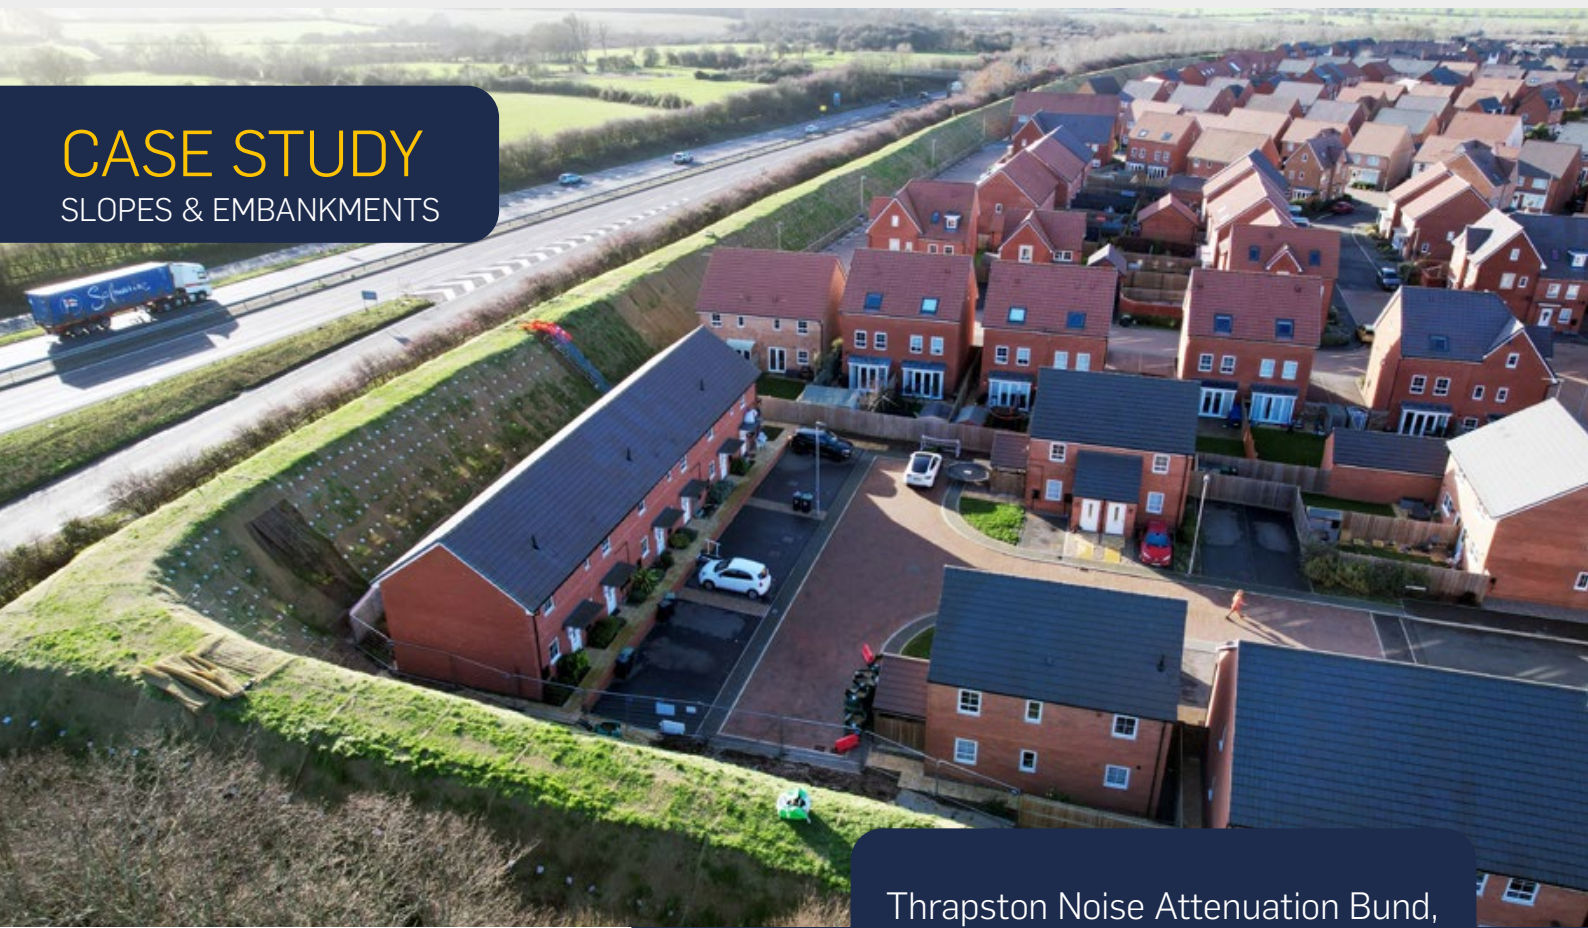
A noise attenuation bund between the A14 and a new housing development raised concerns over its long-term stability. This Long Linear Asset varied between 5-6m high, with a total linear extent of 500m and steep slope angles up to 70°. The bund was formed from site-won soils, including uncompacted clay of poor soil strength. Over time, tension cracks within the surface soils and occasional signs of minor slippages and bulging developed along its length. Intervention was needed to ensure public safety and protect neighbouring properties. The Platipus Low Carbon Anchoring Solution (LCAS®) was chosen for its versatility, given the soil variability and site constraints. As an alternative method, the Platipus System provided immediately quantifiable loads, allowing significant remediation without the need to return to worked areas.

The stabilisation approach needed to minimise disruption while providing a cost-effective and sustainable method to stabilise the bund. Following the strimming of vegetation, 4,000 Percussion Driven Earth Anchors (PDEA®) with a 60-year design life were driven perpendicular to the slope face to alternating 3.5m and 4.5m depths. Installation required a combination of hand-held tools and tracked excavators with specialist rope access to overcome site constraints. Each anchor was

proof tested with a design load of 20kN, ensuring intimate contact of the geotextile with the soil surface, preventing shallow seated failures, surface washout and wind erosion. The facing material was draped over the bund and terminated with two rows of anchors driven vertically due to space constraints not allowing conventional anchoring trenches. To further improve stability, two rows of Plati-Drain™ were driven at a 5° inclination at the toe of the slope to provide long-term drainage to reduce pore water pressure. The result was a cost-effective and environmentally sensitive solution to stabilise the bund, improve resilience, restore appearance through revegetation, and provide peace of mind for nearby residents.
